EXISTING STATIONS CONDITIONS REPORT

Chicago Transit Authority - Strategic Planning
 Blue Line Forest Park Branch Feasibility / Vision Study
Existing Conditions Assessment Report
Forest Park Station

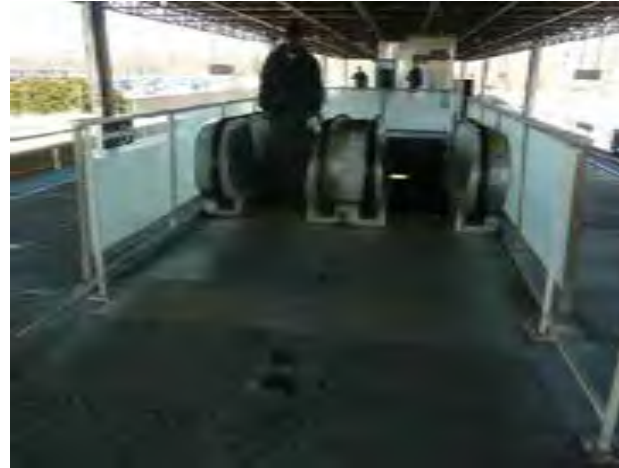
View of escalators at east portion of platform

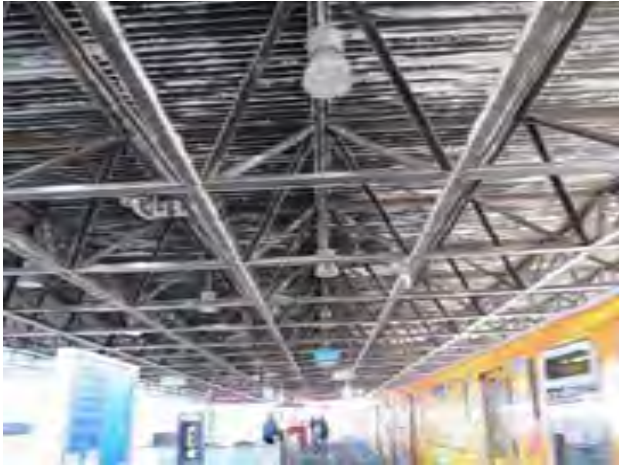
View of peeling paint and rusting components at platform canopy structure

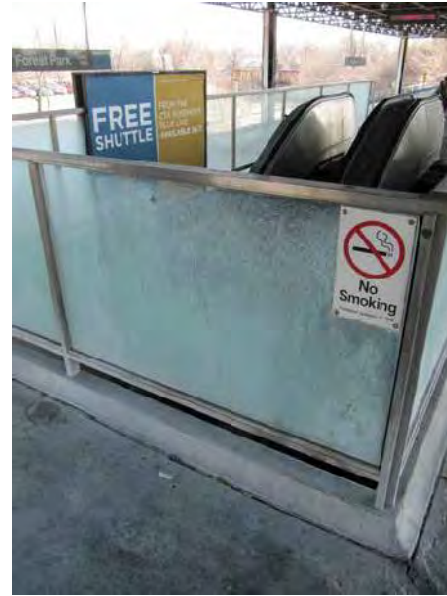
View of whitish surface deposits on guardrails, concrete and railings throughout the platform area.

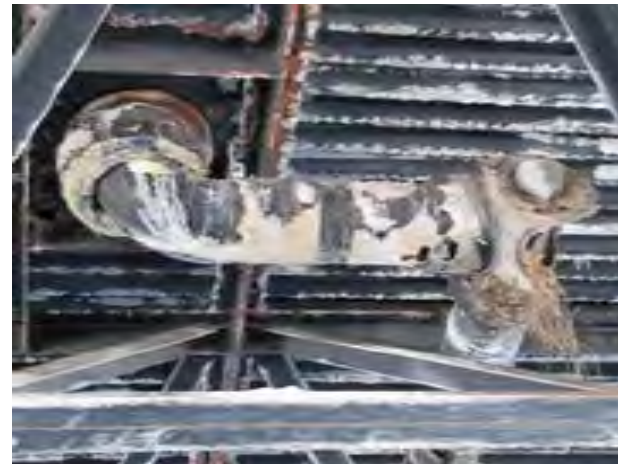
View of corroded roof drain with birds nest at platform level canopy

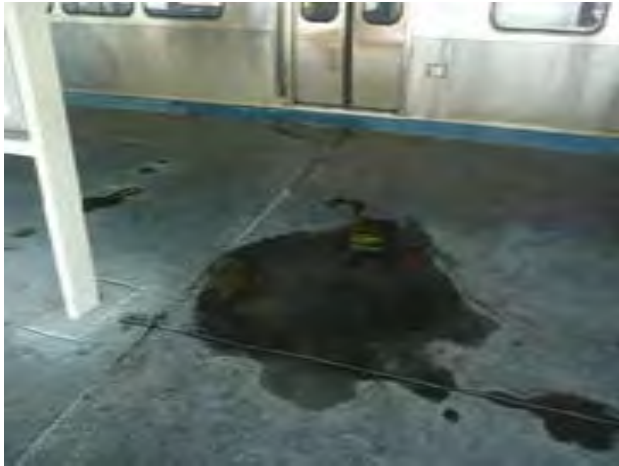
Evidence of roof drains leaking on platform level

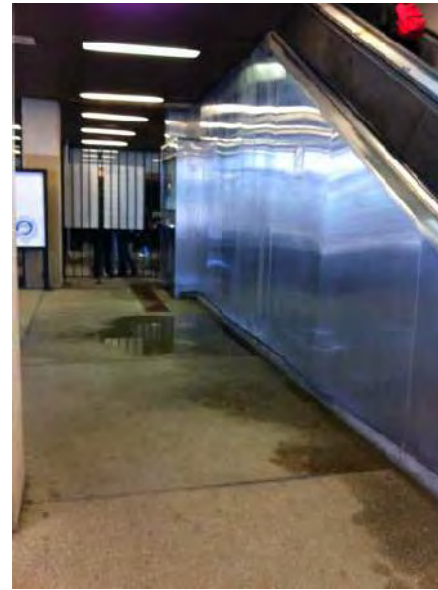
View of roof drains leaking at escalator enclosure down into paid area

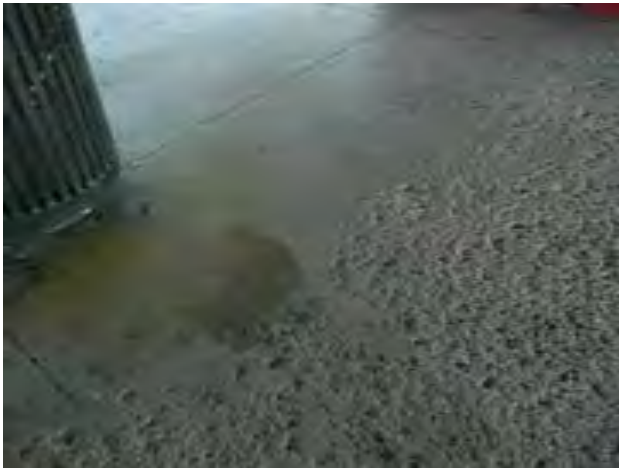
View of spalling concrete at platform surface

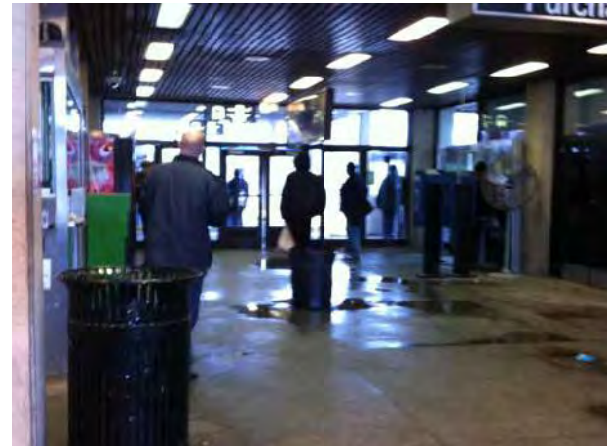
View of roof drains leaking through ceiling at unpaid area

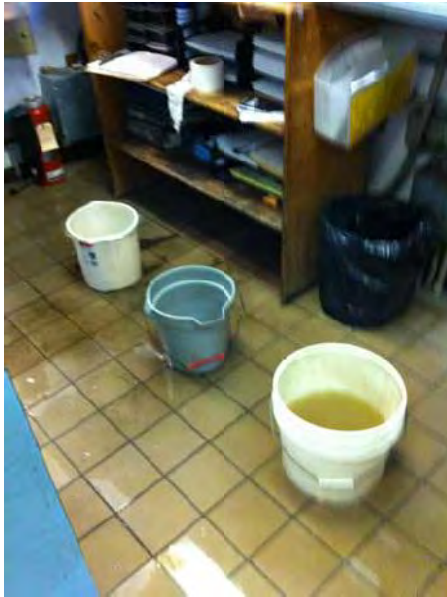
View of roof drains
leaking through ceiling
at customer service
kiosk

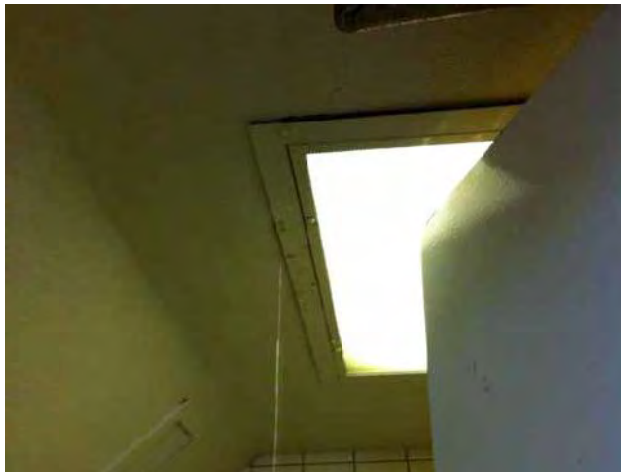
View of roof drains
leaking through ceiling
at customer service
kiosk toilet room ceiling

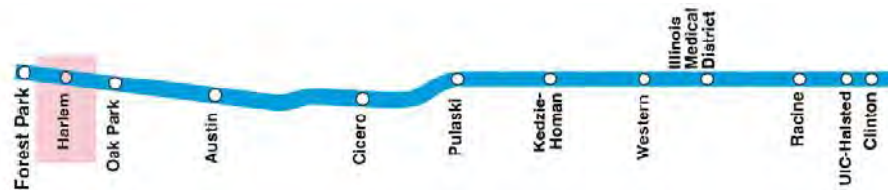
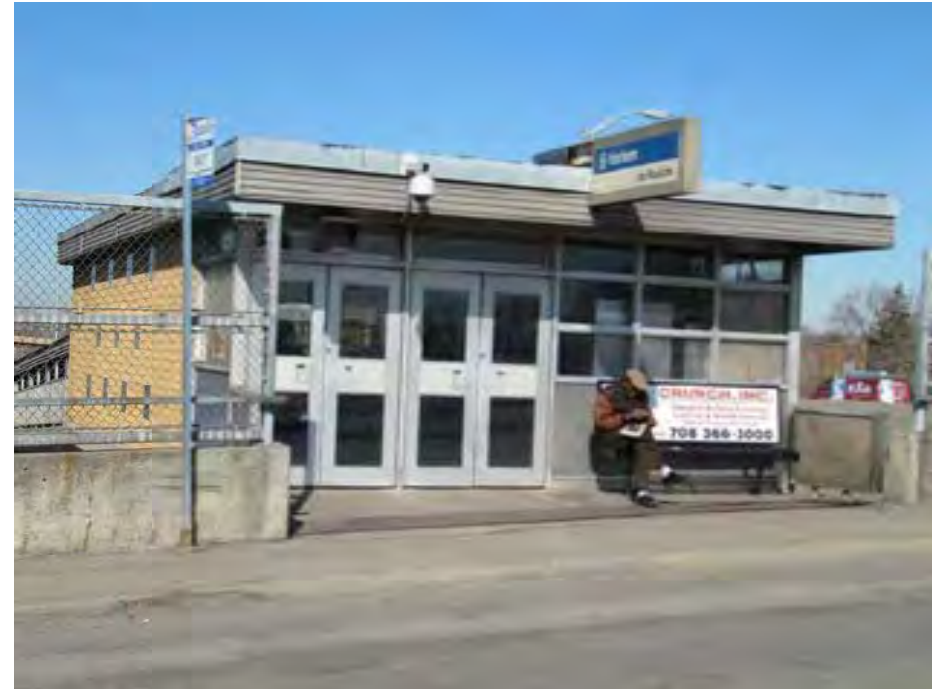
Chicago Transit Authority - Strategic Planning
 Blue Line Forest Park Branch Feasibility / Vision Study
Existing Conditions Assessment Report
Harlem Station

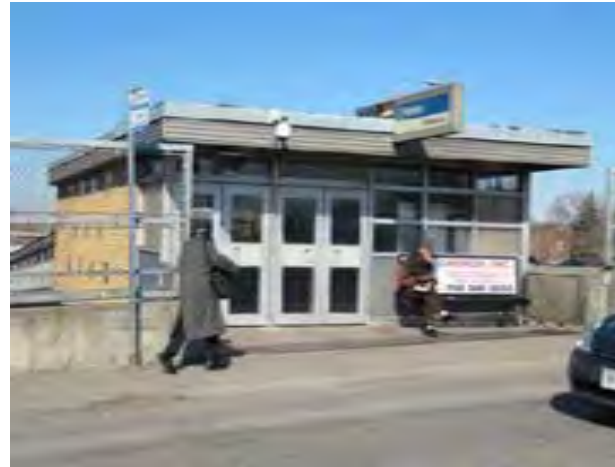
View of main station entry at Harlem Avenue

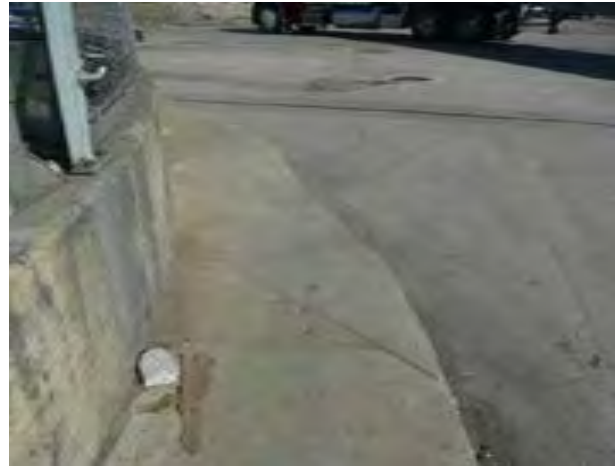
View of non-compliant curb ramp at Harlem Avenue on approach to station. Note that the pedestrian crosswalk is not identified with striping

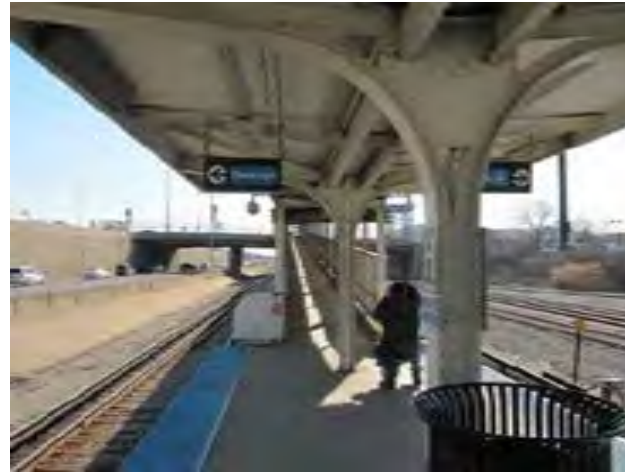
View of exit ramp at east end of platform

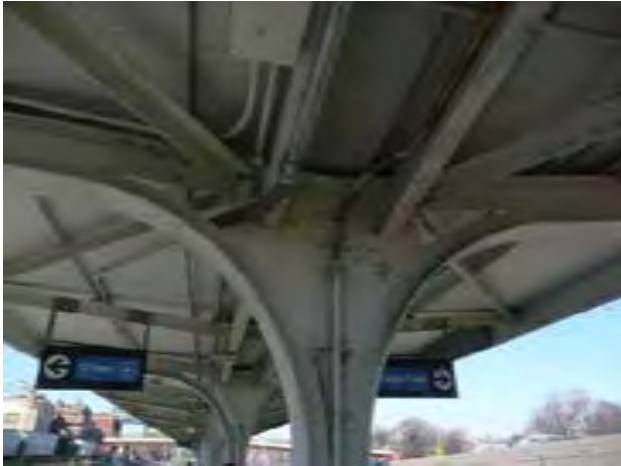
View of peeling paint and rusting conduit at platform canopy structure

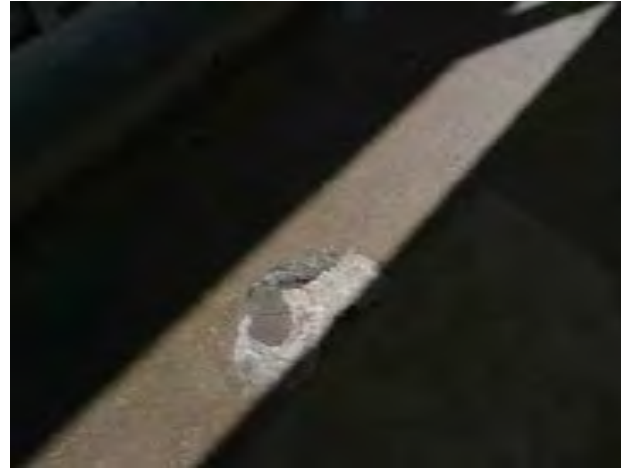
View of broken concrete and patch at ramp surface

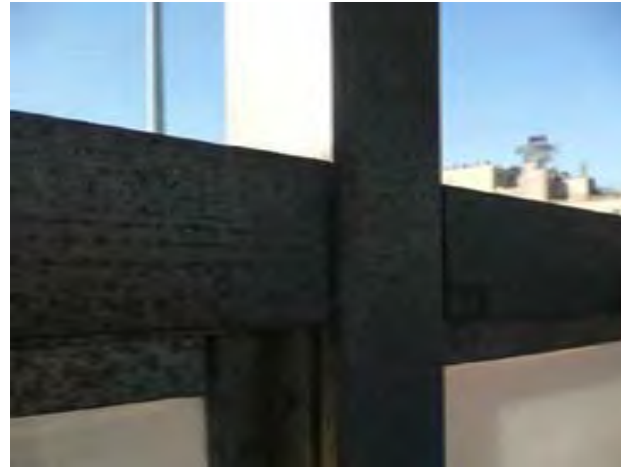
View of corroded surface of wind break enclosure at ramp

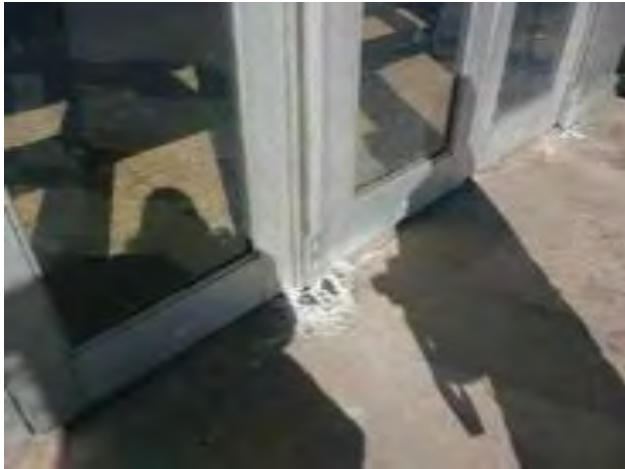
View of corrosion and deterioration at base of main entry doors

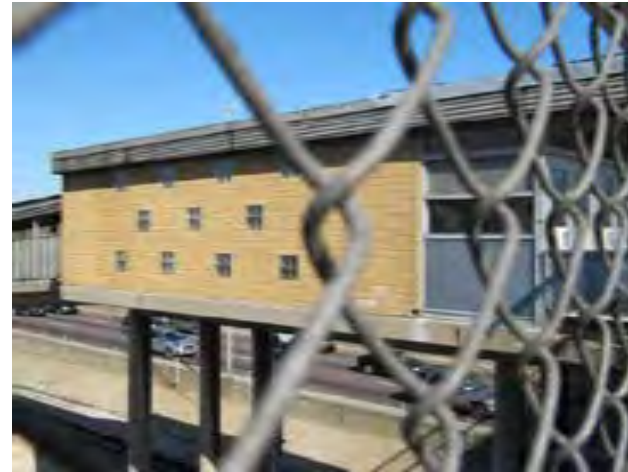
View of Harlem Stationhouse showing roof edge condition, brick condition and evidence of water infiltration to rebar within concrete.

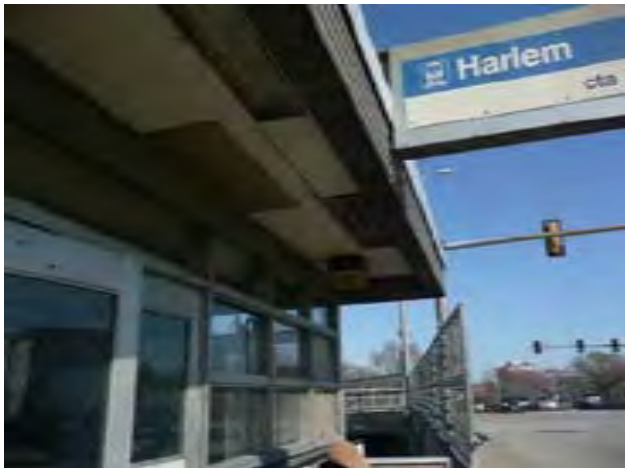
View of missing light diffusers and panels at roof eave at main station entry

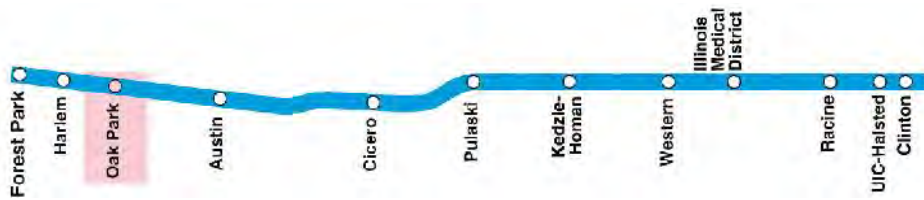
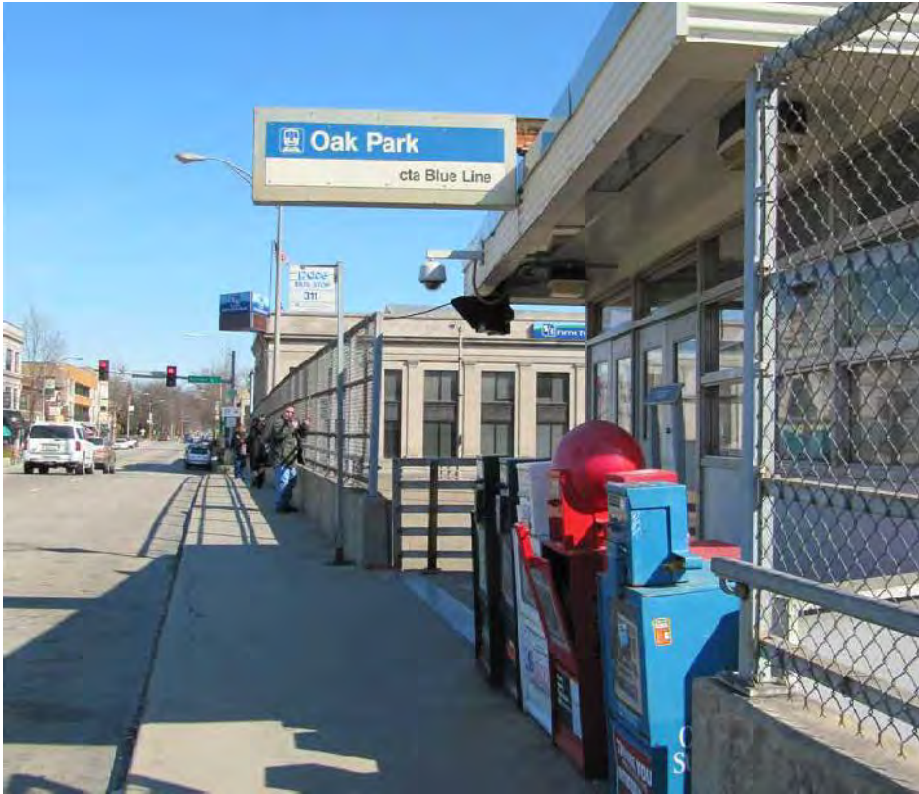
Chicago Transit Authority - Strategic Planning
 Blue Line Forest Park Branch Feasibility / Vision Study
Existing Conditions Assessment Report
Oak Park Station

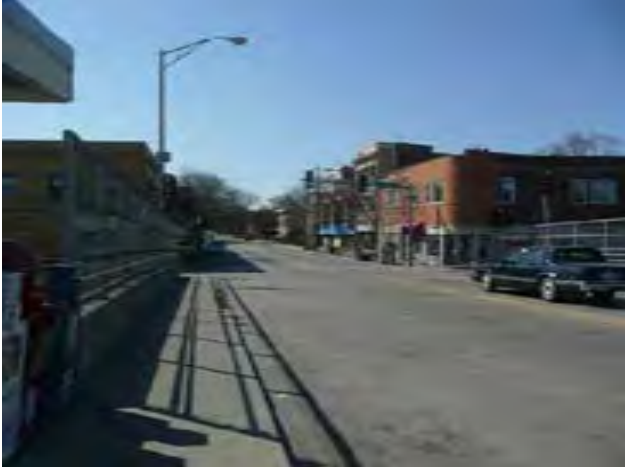
View of accessible sidewalk along Oak Park Avenue on approach to station

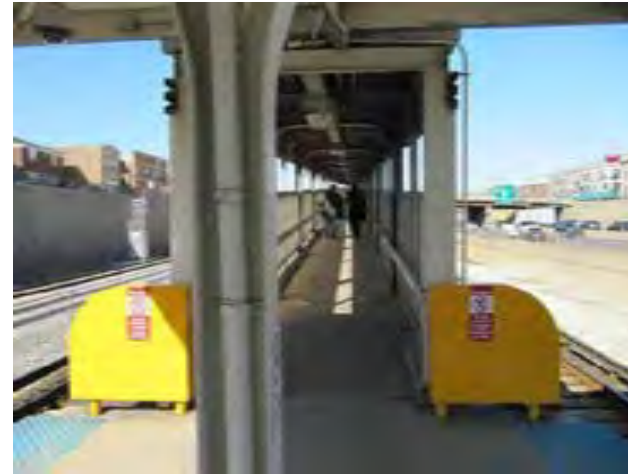
View of exit ramp at west end of platform

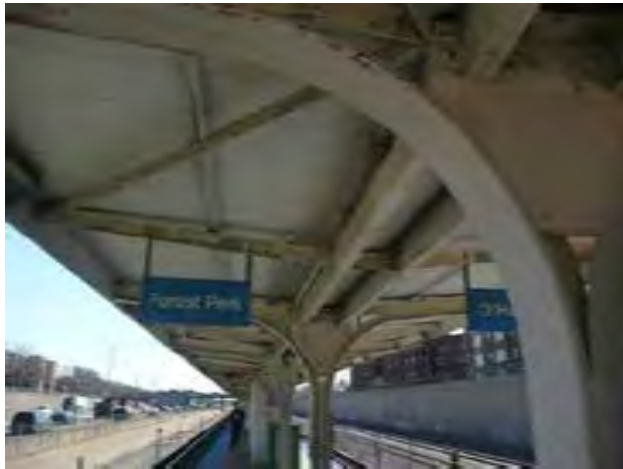
View of peeling paint and rusting conduit at platform canopy structure

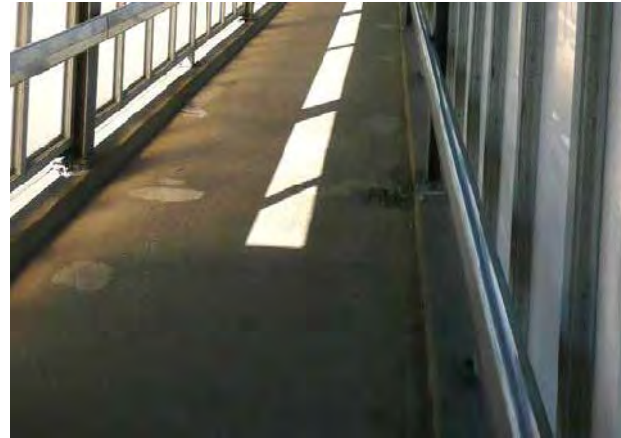
View of broken concrete and patch at ramp surface

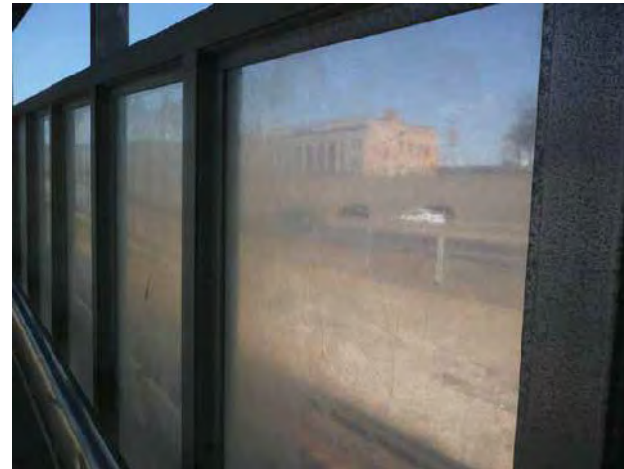
View of aged plastic panels and corroded aluminum surface of wind break enclosure at ramp

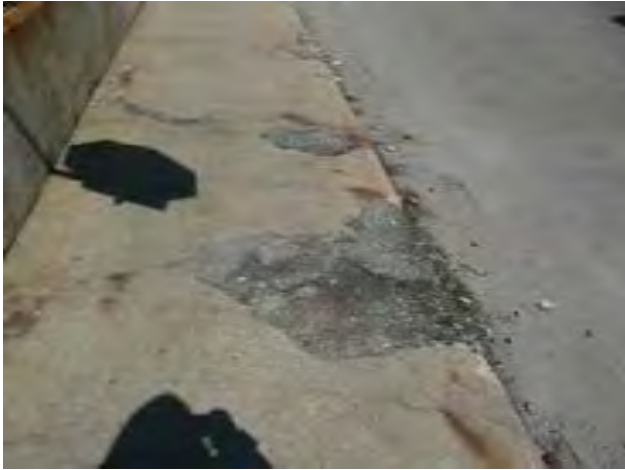
View of broken and patched sidewalk along East Avenue near stationhouse entry

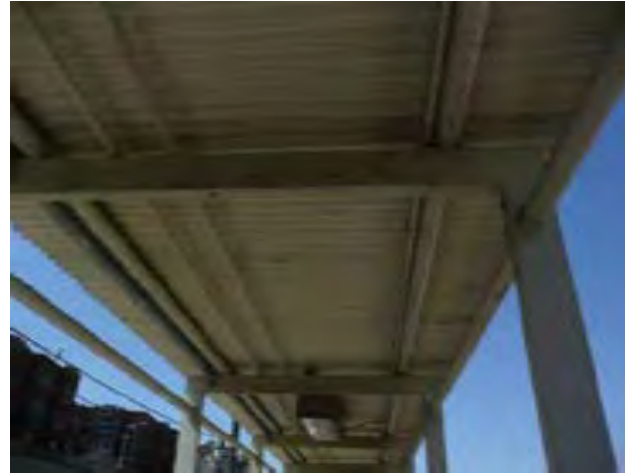
View of peeling paint at walkway canopy near East Avenue platform entry

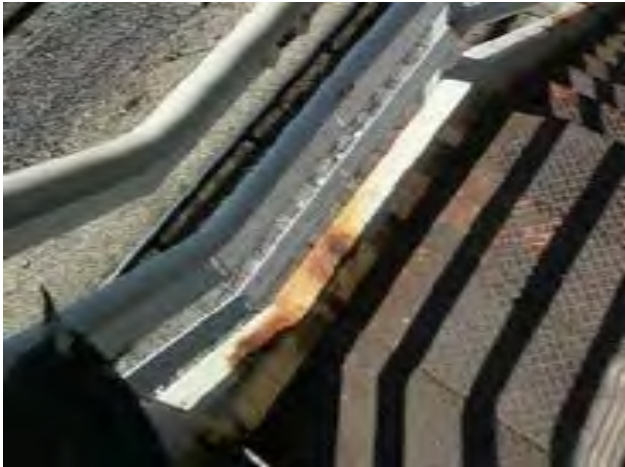
View of rusting structure at stair near East Avenue entry

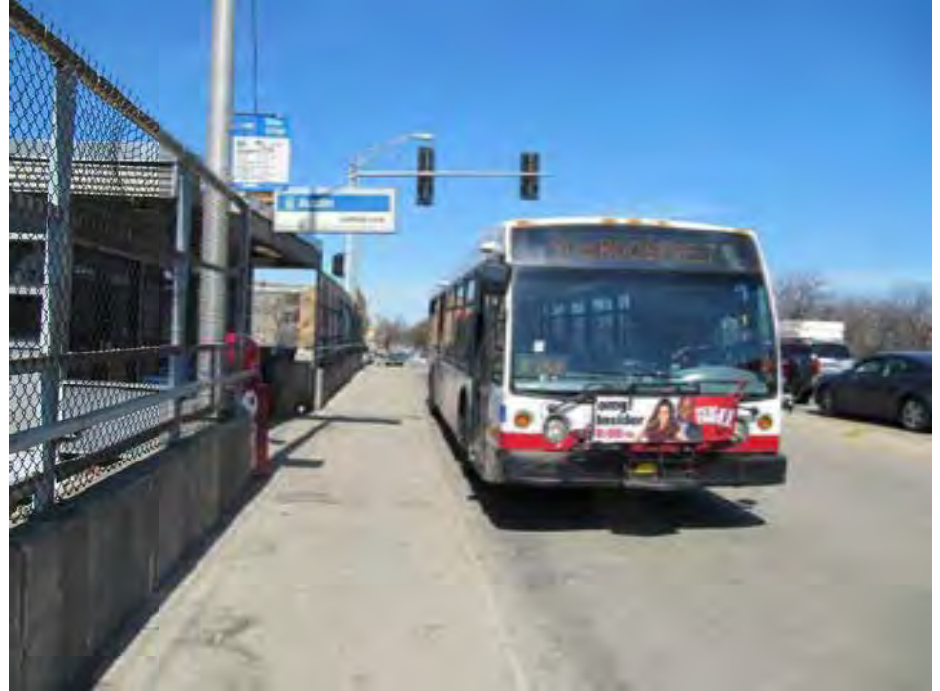
Chicago Transit Authority - Strategic Planning
Blue Line Forest Park Branch Feasibility / Vision Study
Existing Conditions Assessment Report
Austin Station

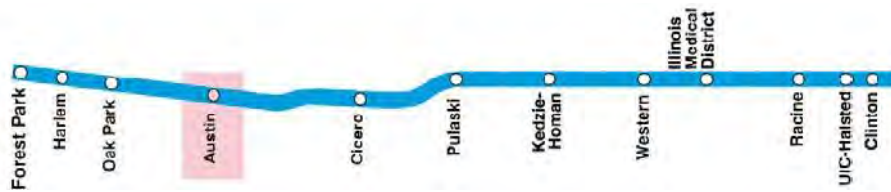
Prepared by: Parsons Brinckerhoff and Ross Barney Architects

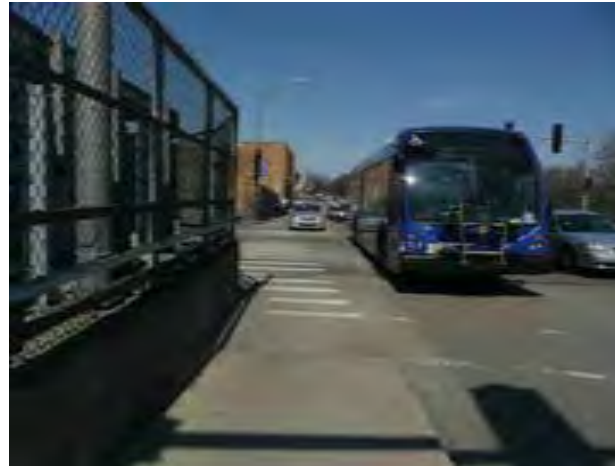
View of non-compliant curb ramp at Austin Avenue on approach to station.

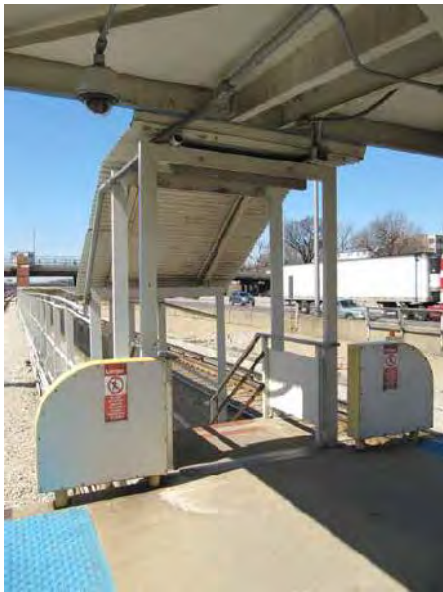
View of exit stair and walkway at west end of platform

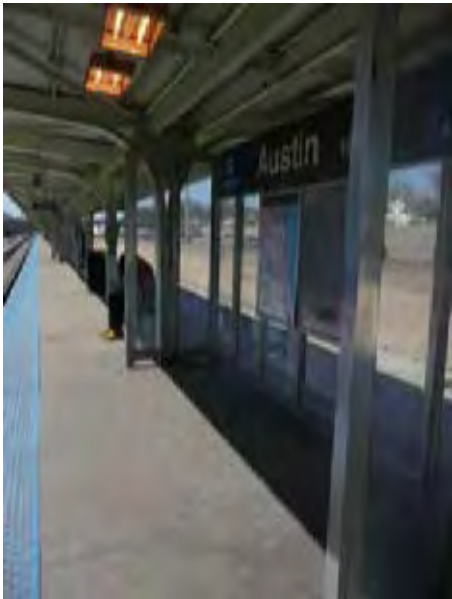
View of peeling paint at platform canopy structure

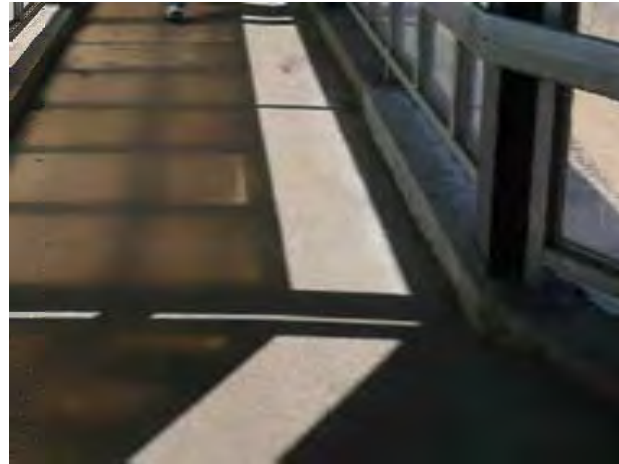
View of broken concrete and patching at ramp surface

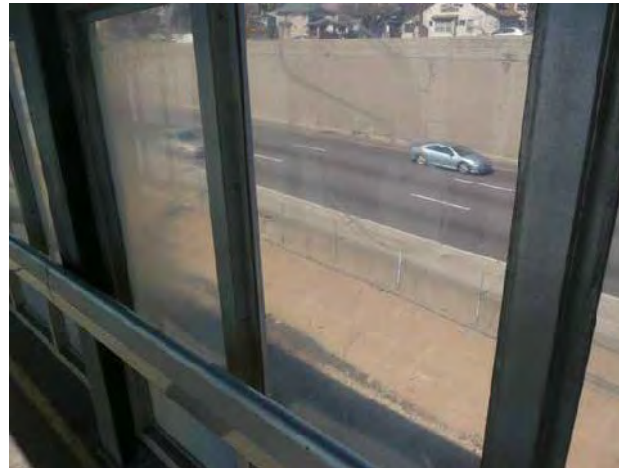
View of scratched and corroded surface of wind break enclosure at ramp

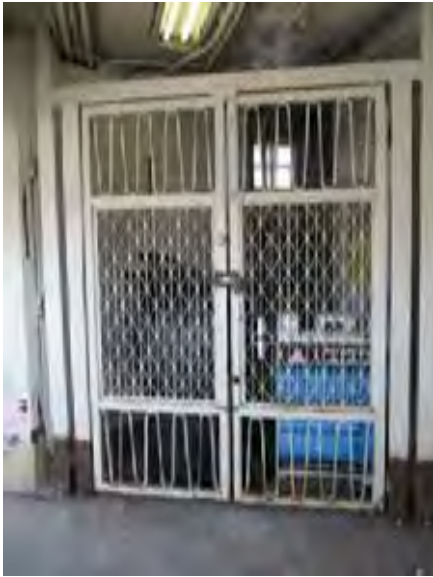
View of corrosion and deterioration at base of gates and main stationhouse

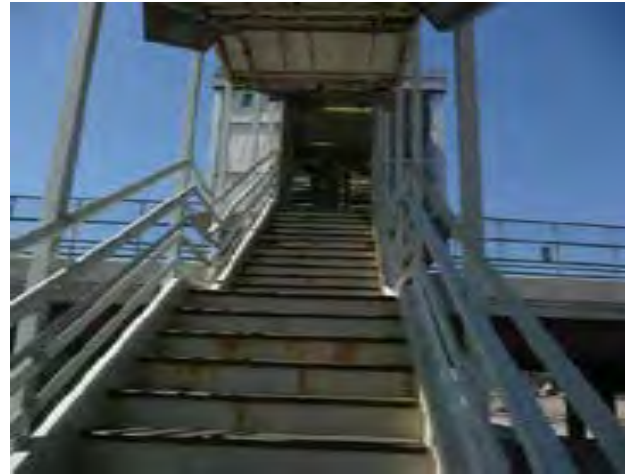
View of west exit stair showing rust at risers

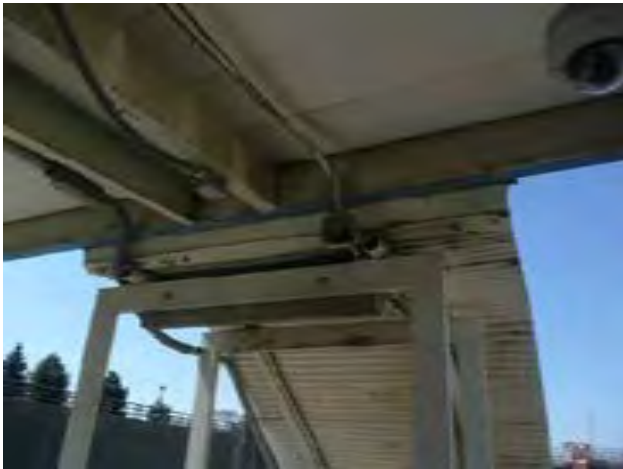
View of corrosion and peeling paint at platform canopy and walkway canopy at west end of station

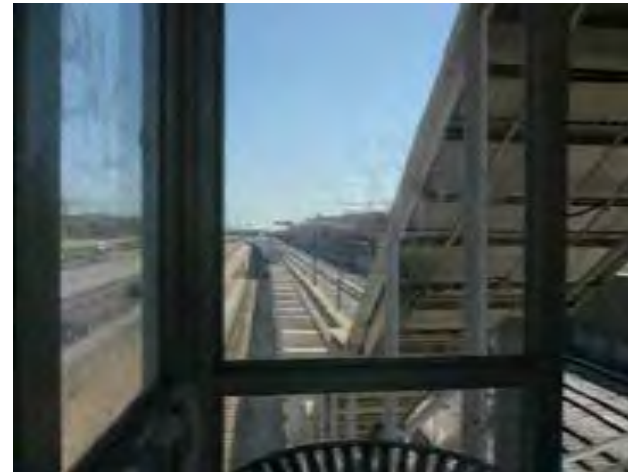
View of west stationhouse windbreak enclosure showing scratches and deterioration

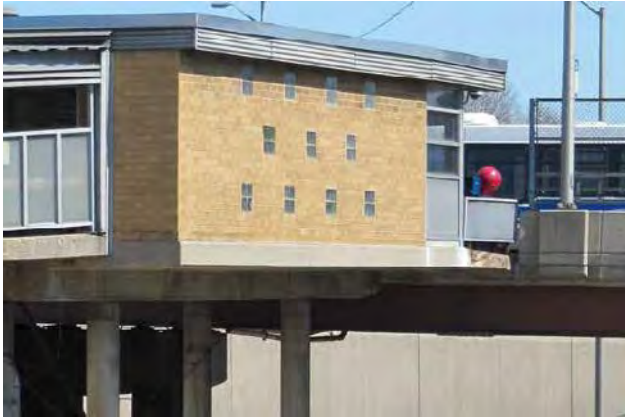
View of Austin Stationhouse showing deterioration and spalling at concrete near guardrail

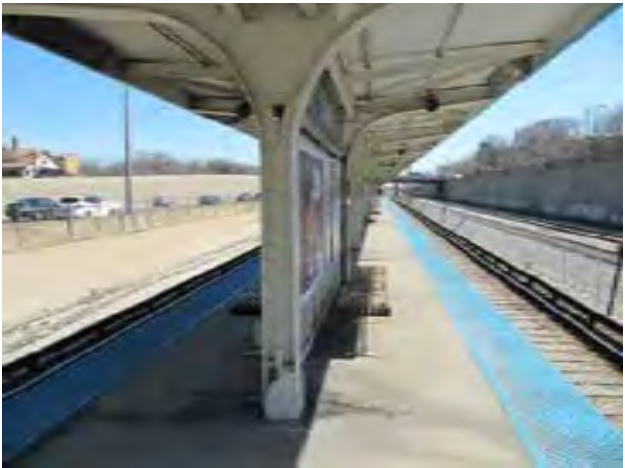
View of Austin Platform showing broken concrete near base of platform canopy columns

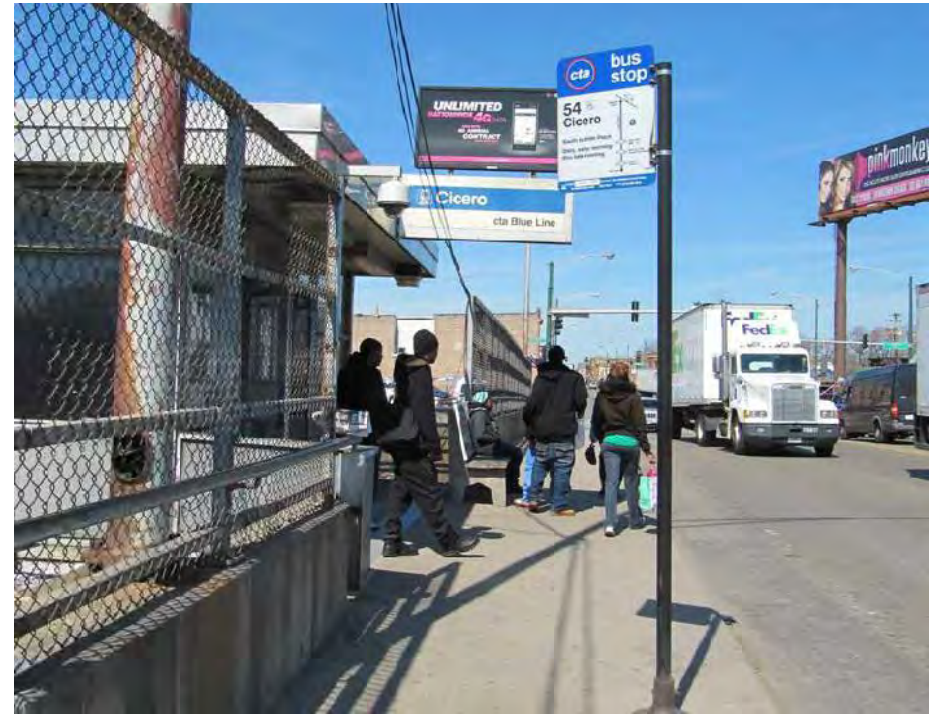
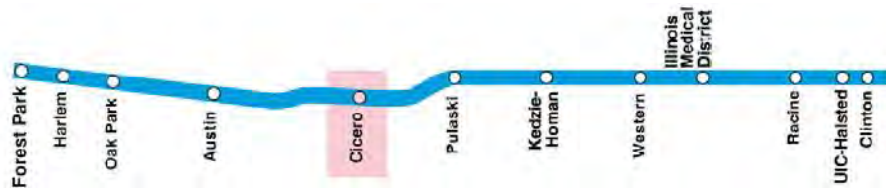
Chicago Transit Authority - Strategic Planning
 Blue Line Forest Park Branch Feasibility / Vision Study
Existing Conditions Assessment Report
Cicero Station

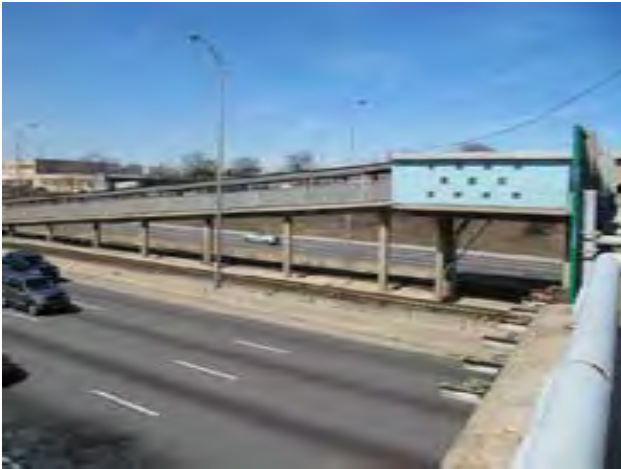
View of main station house and entry ramp at Cicero Avenue

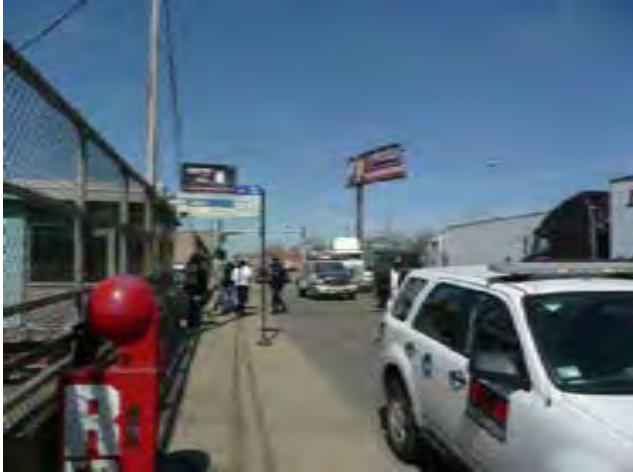
View of sidewalk along Cicero Avenue on approach to station

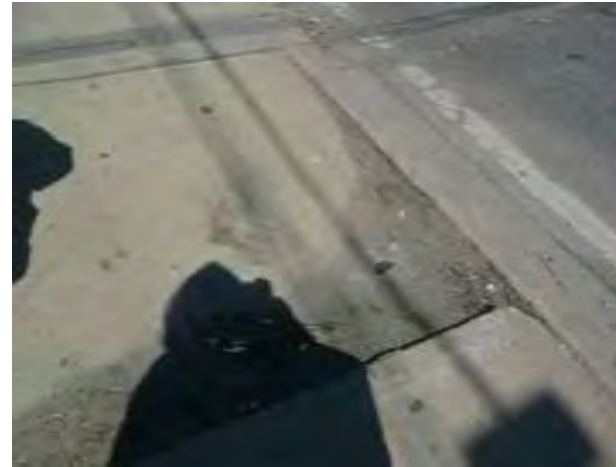
View of sidewalk condition along Cicero near Lexington. Note broken and sunken portion of sidewalk that should be repaired.

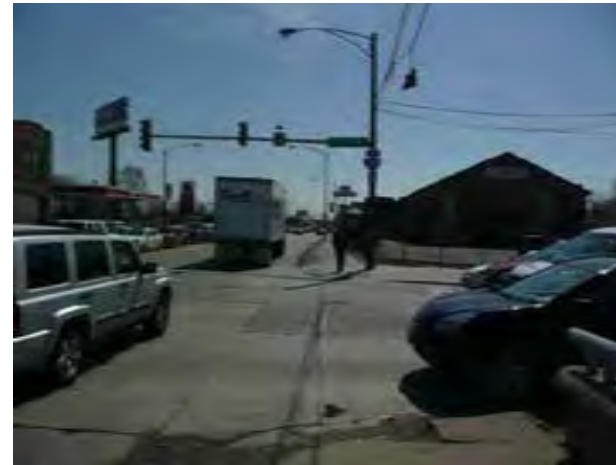
View of crosswalk and curb ramp at Cicero and Lexington intersection. Note broken sidewalk curb ramp that should be repaired.

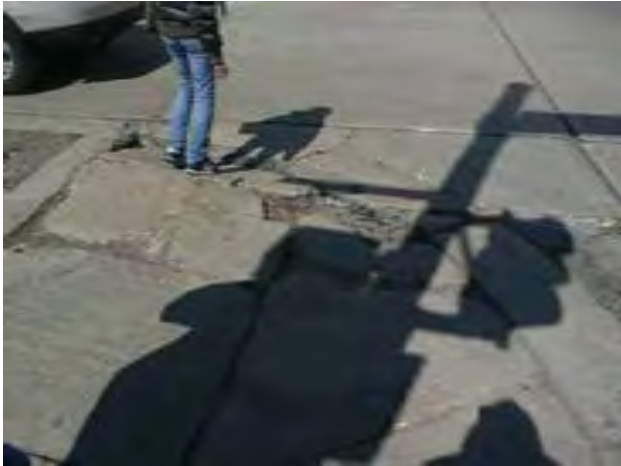
View of crosswalk and curb ramp at Cicero and Flournoy intersection. Note broken sidewalk curb ramp that should be repaired.

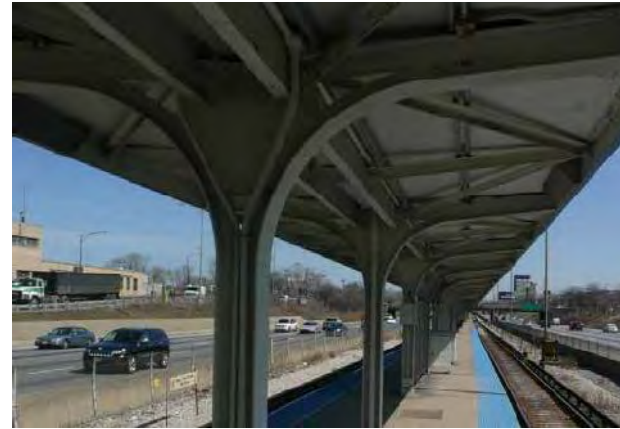
View of non-compliant platform with impeding elements

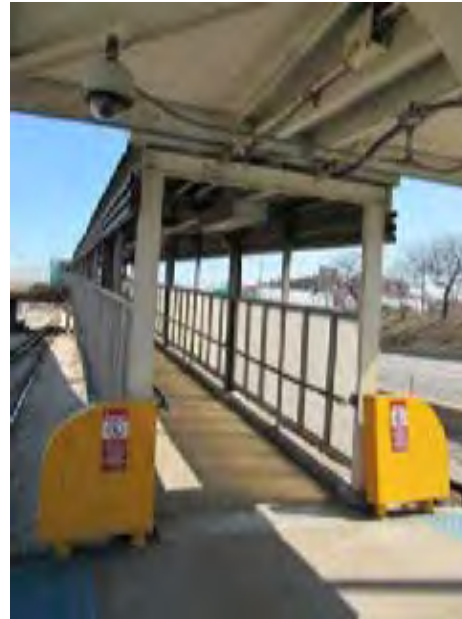
View of exit ramp at east end of platform

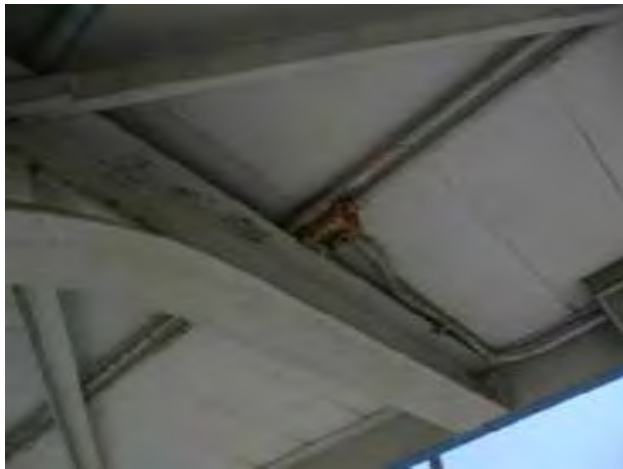
View of peeling paint and rusting conduit and junction box at platform canopy structure

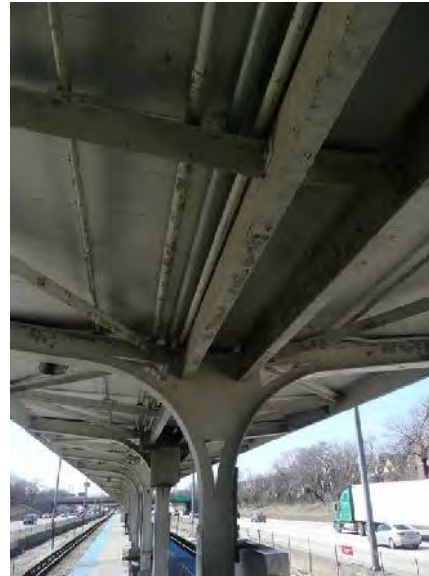
View of peeling paint at platform canopy structure

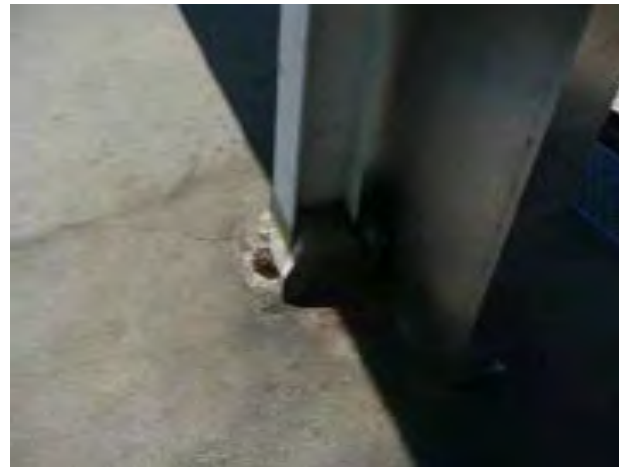
View of broken concrete at base of platform canopy columns.

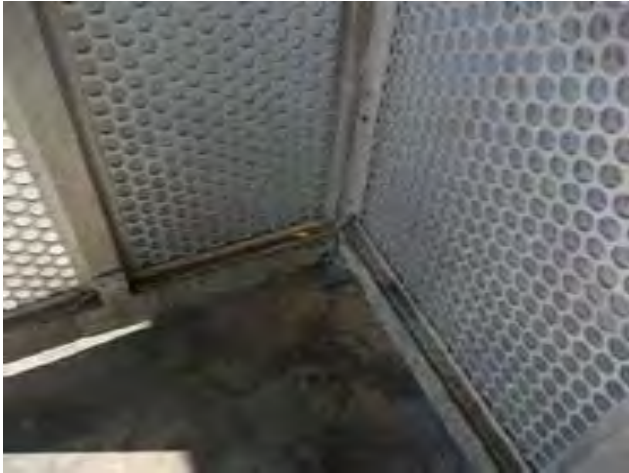
View of corrosion at windbreaks on platform

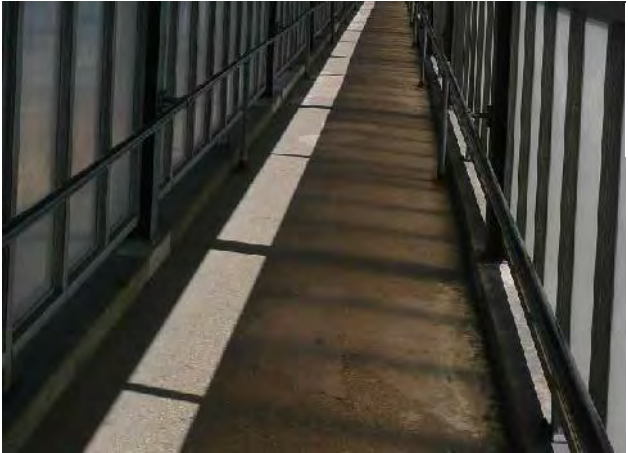
View of broken concrete and patches at ramp surface. Note rusting at base of handrail support posts.

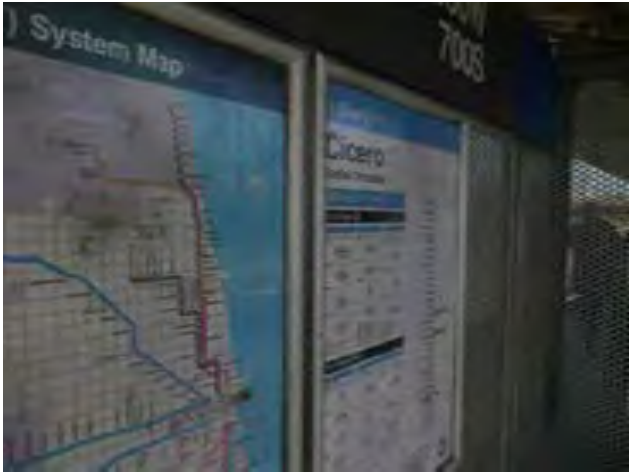
View of graffiti and scratches at platform signage

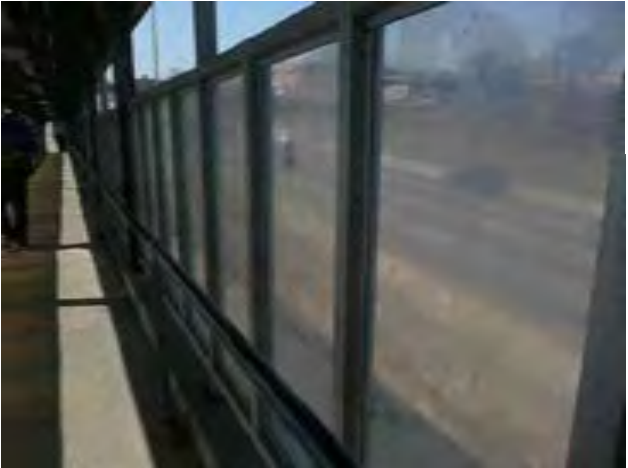
View of corrosion and aged, scratched surface of wind break enclosure panels at ramp

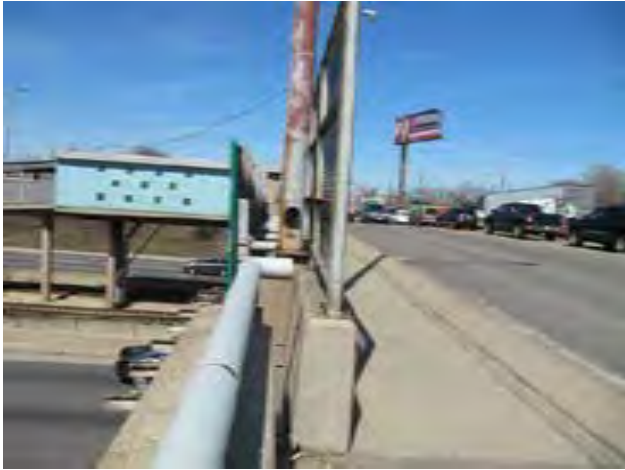
View of corrosion and open electrical junction box at light post on Cicero bridge overpass.

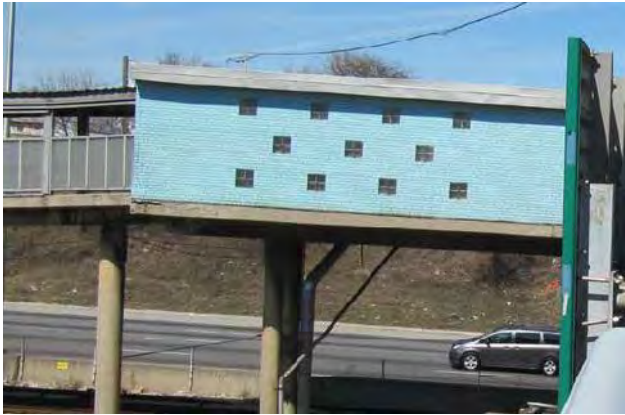
View of cracked and spalled concrete at base of stationhouse wall

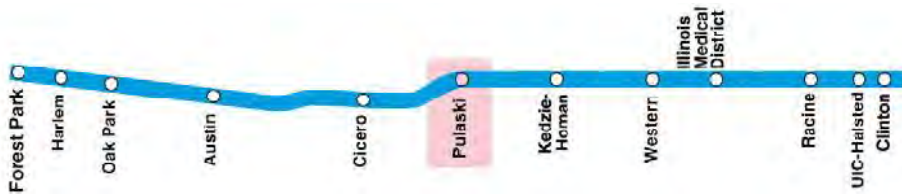
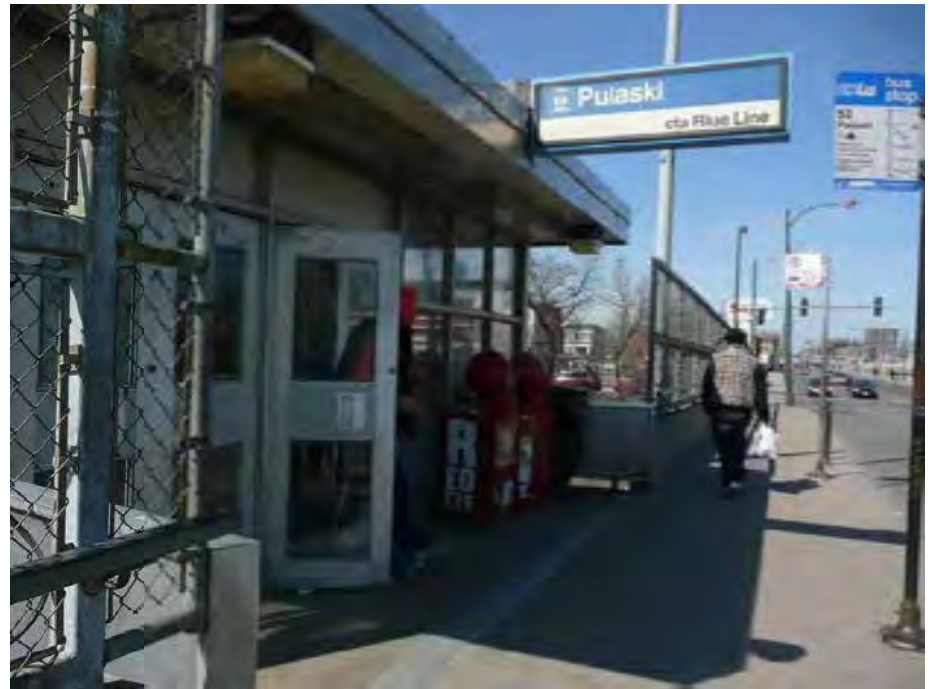
Chicago Transit Authority - Strategic Planning
 Blue Line Forest Park Branch Feasibility / Vision Study

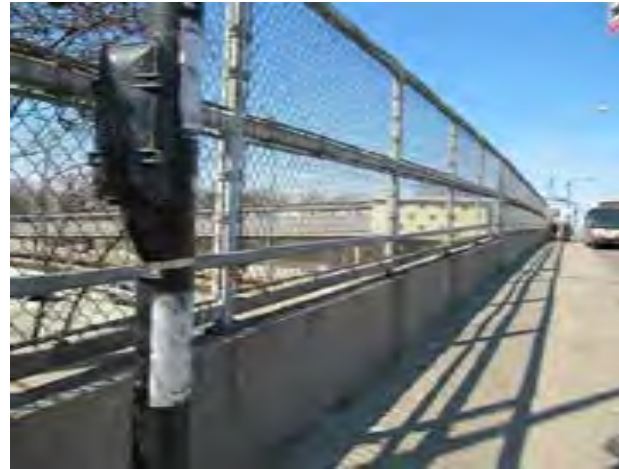
View of main stationhouse and entry ramp at Pulaski Road

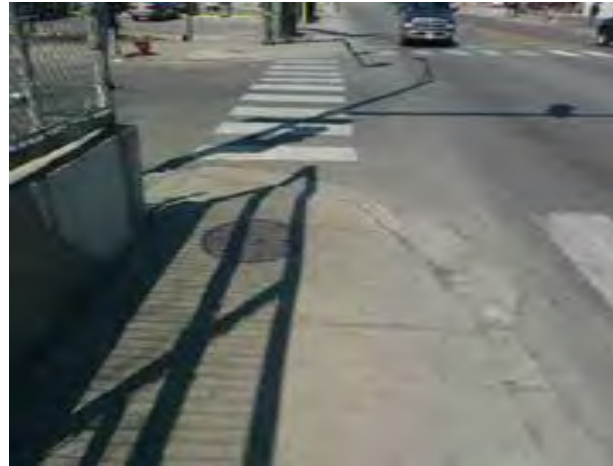
View of sidewalk condition along Pulaski near Congress Note broken sidewalk and portions of curbs that should be repaired.

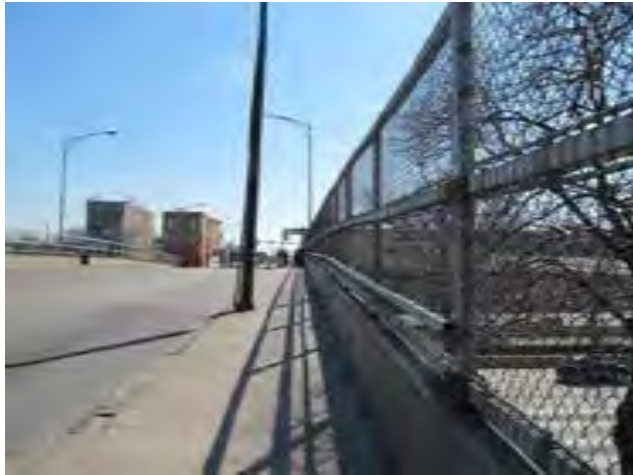
View of sidewalk along Pulaski Road on approach to station

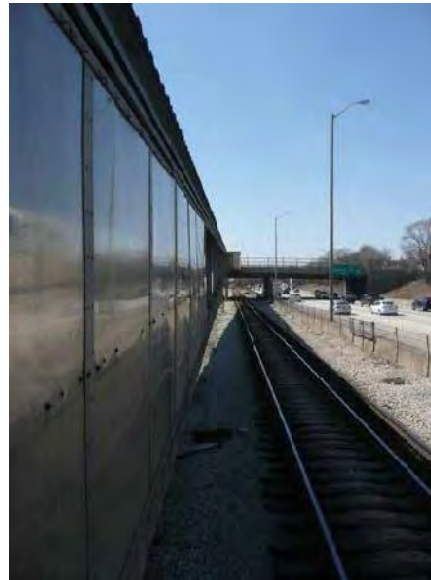
View of exit ramp at east end of platform

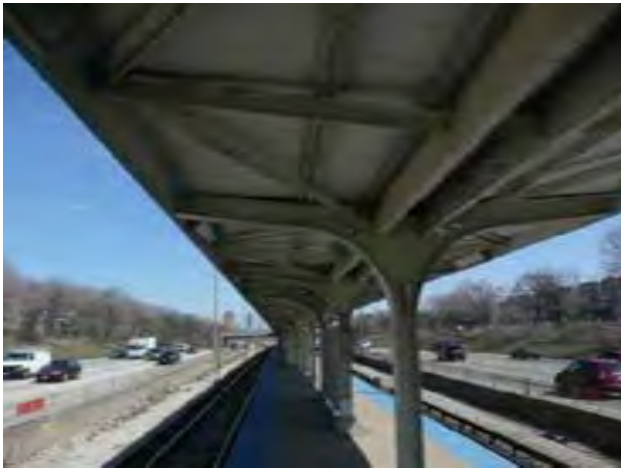
View of peeling paint and rusting at platform canopy structure

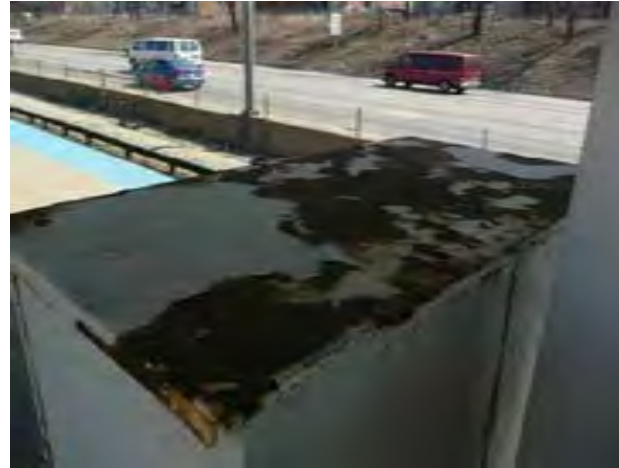
View of peeling paint and rusting at platform storage box elements.

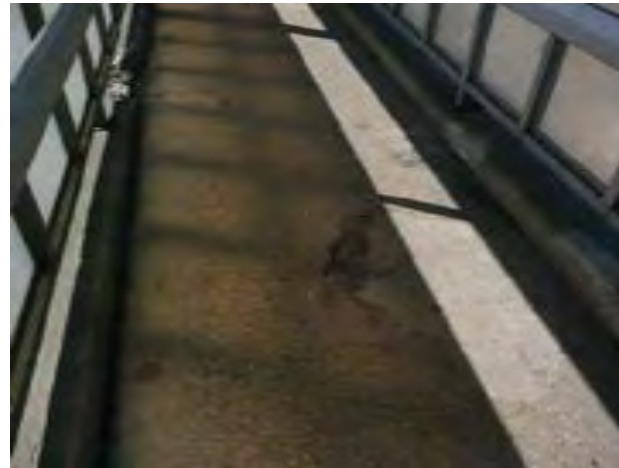
View of broken concrete at ramp walking surface. Note also broken concrete curb at wind break
