EXISTING STATIONS CONDITIONS REPORT

Chicago Transit Authority - Strategic Planning
 Blue Line Forest Park Branch Feasibility / Vision Study
Existing Conditions Assessment Report
Forest Park Station

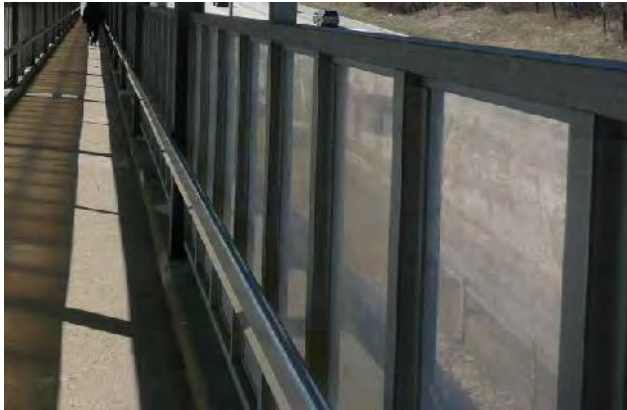
View of corrosion and aged plastic panels at windbreaks on ramp

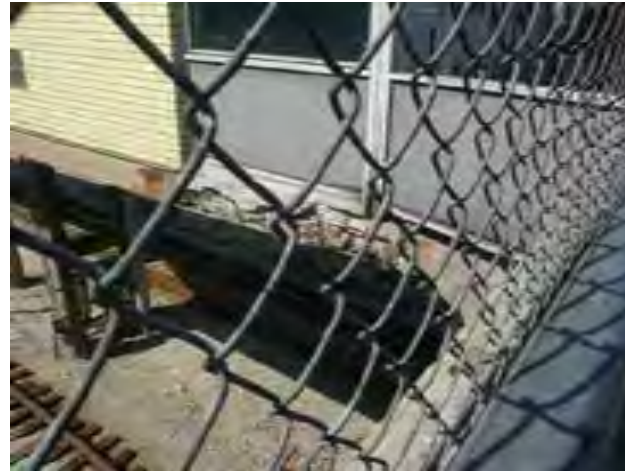
View of cracked and spalled concrete at base of stationhouse wall. Note re-bar is exposed and deterioration is advanced.

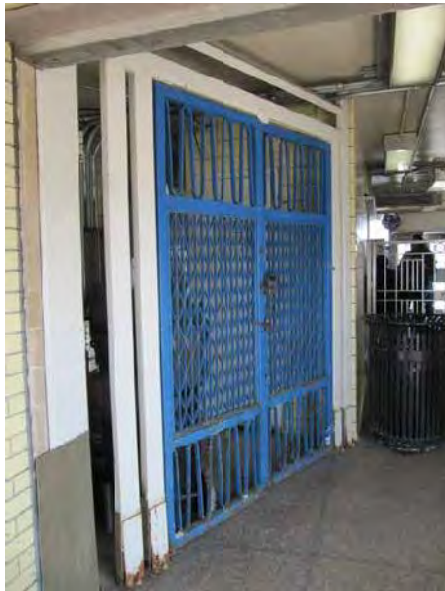
View of corrosion at base of gates in Pulaski Road stationhouse
